ESTCP Cost and Performance Report

(CP-9506)

Photocatalytic Destruction of Nitrate Esters in Air

July 2000

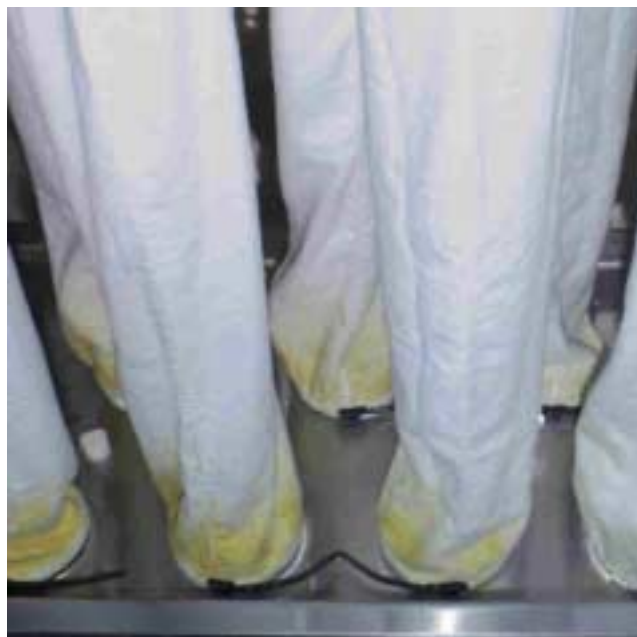
The non-uniform deposition of contaminants is clearly illustrated in the photographs in Figures 7 and 8 of the used socks from Test Three. The stains located on the outside of the socks indicated the area on which contaminants were concentrated. Since the stains were not uniformly distributed along the length of the socks, it seems reasonable to conclude that the NG was not uniformly distributed along the length of the socks. Figure 8 also clearly shows that the first 4 inches of the socks are a different color than the remainder of the sock. This area corresponded to the portion of the sock in which no lamp extended and indicated an area of less photocatalytic activity.

Figure 7. Used Catalyst Socks in Bank A after Test Three.

Figure 8. Used Catalytic Socks in Bank B after Test Three.

Inspection of the catalyst socks at the completion of the Test Three resulted in several important observations. There were stains on the outside of the socks, which had never been seen before. Although the outsides of the socks were stained, the interiors of the socks were uniform in color. Perhaps more importantly, the socks in Bank B of each module were not as discolored as in the previous two tests. In fact, the socks in Bank B looked reusable as shown in Figure 6. Two socks were sampled from each module for residual NG measurements. The socks were taken from opposite ends of the same bank. The residual NG measurements for Bank A showed a per sock concentration of 52 and 9 mg. The high concentration occurred at the end of the unit farthest from the inlet. Bank B showed no difference between the positions, and each sock contained 26 mg of NG.

There was a distinct color difference between the Bank A socks of Tests One and Two, which were exposed to UV light for a short time, and those of Test Three, which were exposed to the UV light for 168 hours. In the first two tests, the color was yellow, whereas in the last test the color was dark brown. In the first two tests, the dark discoloration corresponded to reduced performance but, in Test Three, the performance did not seem to decrease. It is thought that the dark coloration was due to degradation of the socks. The socks, although still intact, had suffered mechanical degradation. Upon removal, the socks were very dusty and could be easily torn by hand. The combination of mechanical degradation and discoloration indicated that the socks could not be used continuously for one year. Furthermore, to be sure that the contaminants are destroyed, it is recommended that the socks be replaced after each run.
